Mitigation of the adverse effects of Lake Hāwea Township stormwater entering Lake Hāwea

Prepared by John Langley & Don Robertson

On behalf of the Guardians of Lake Hāwea

17 June 2019

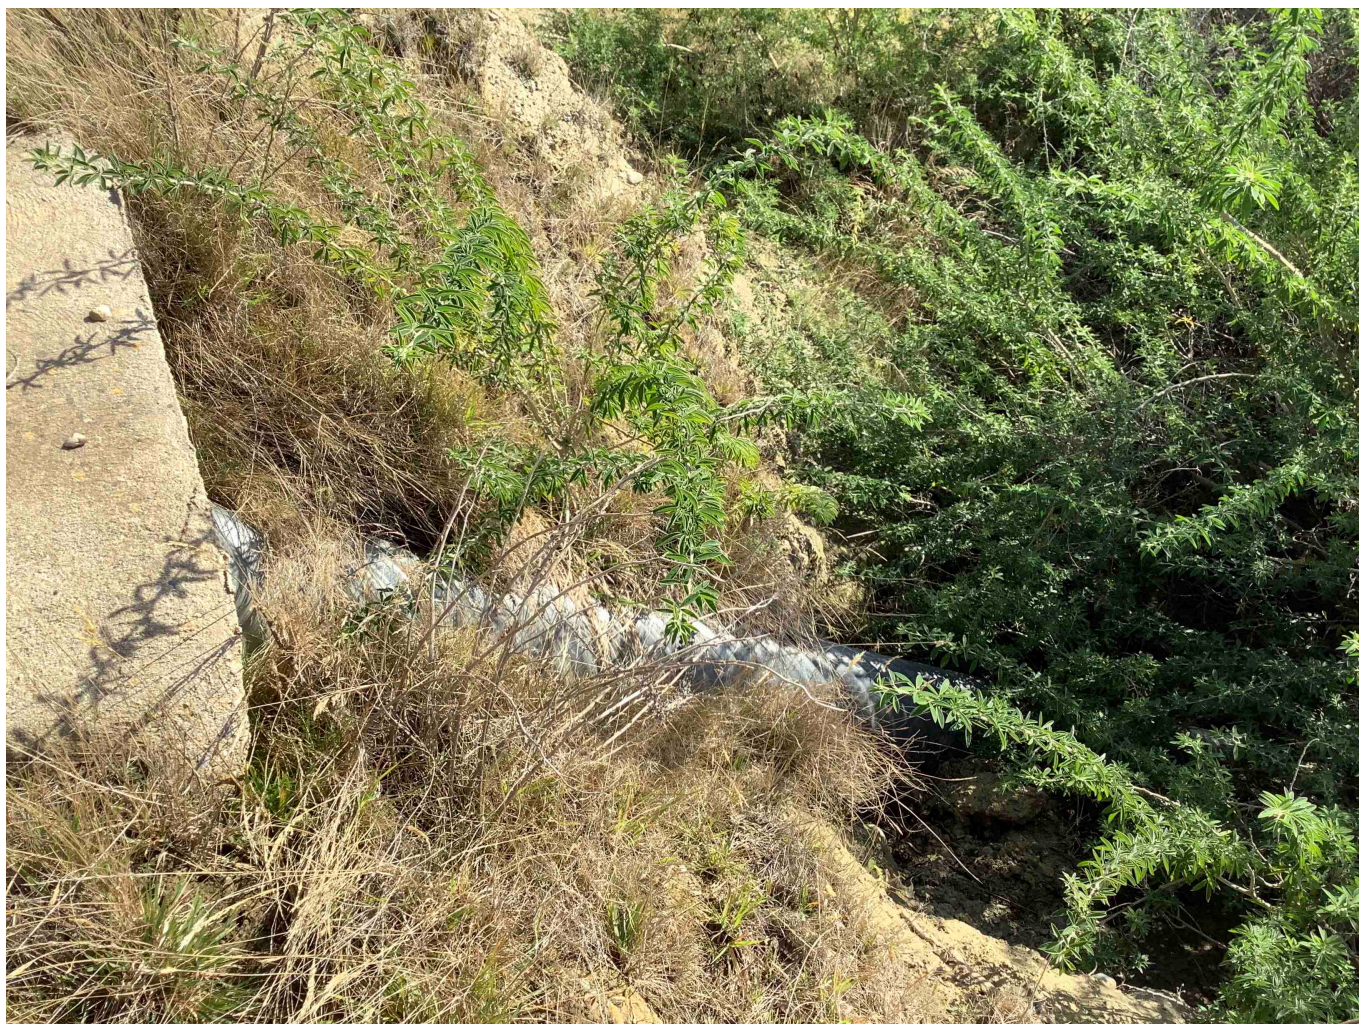
This is a significant system that is piped over the cliff face to the upper edges of the stone foreshore. There is tree lucerne (*Cytissus proliferus*) growing around the exit. There is no significant erosion associated with this discharge.

Fig 2.1 294 Lakeview Tce (31 May 2019)

There is limited opportunity to improve vegetation mitigation, nevertheless it would be worth planting around the exit

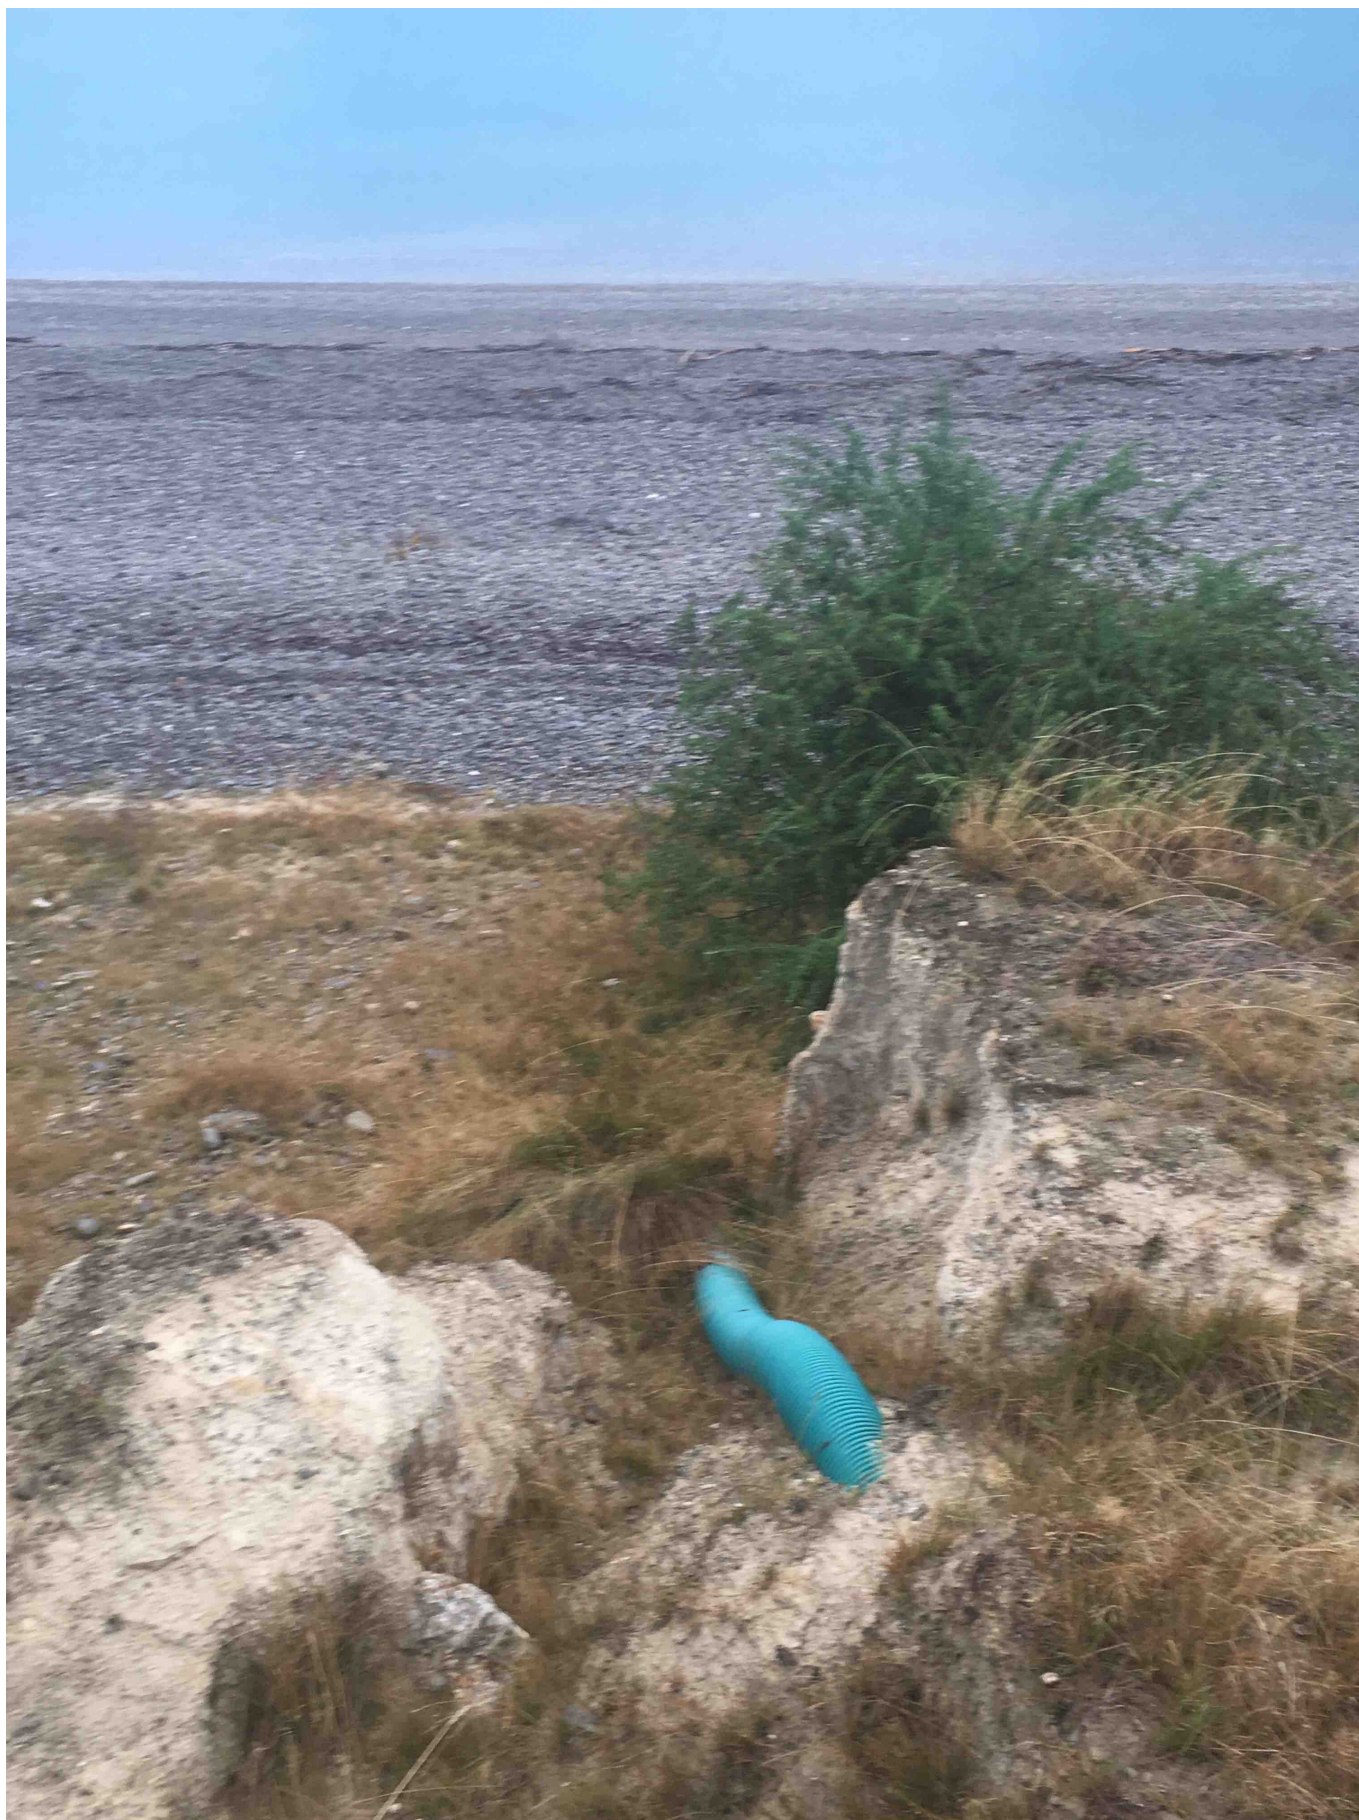
This appears to be a relatively recently installed stormwater discharge system which is associated with a house which was built in the last ten years. This is an unusual situation as it is the only discharge of its kind on the entire township foreshore. The stormwater is piped across the reserve and over the bank where it exits the pipe halfway down the bank and discharges onto grass thence gravel (Fig 3.1). There is no significant erosion associated with this discharge. The erosion shown in Fig 3.1 appears to be due to land run off or possibly excavation during placement of the drain.

Fig 3.1 282/286 Lakeview Tce exit (26 May 2019)

There is a significant opportunity to improve vegetation mitigation around and north of the exit.

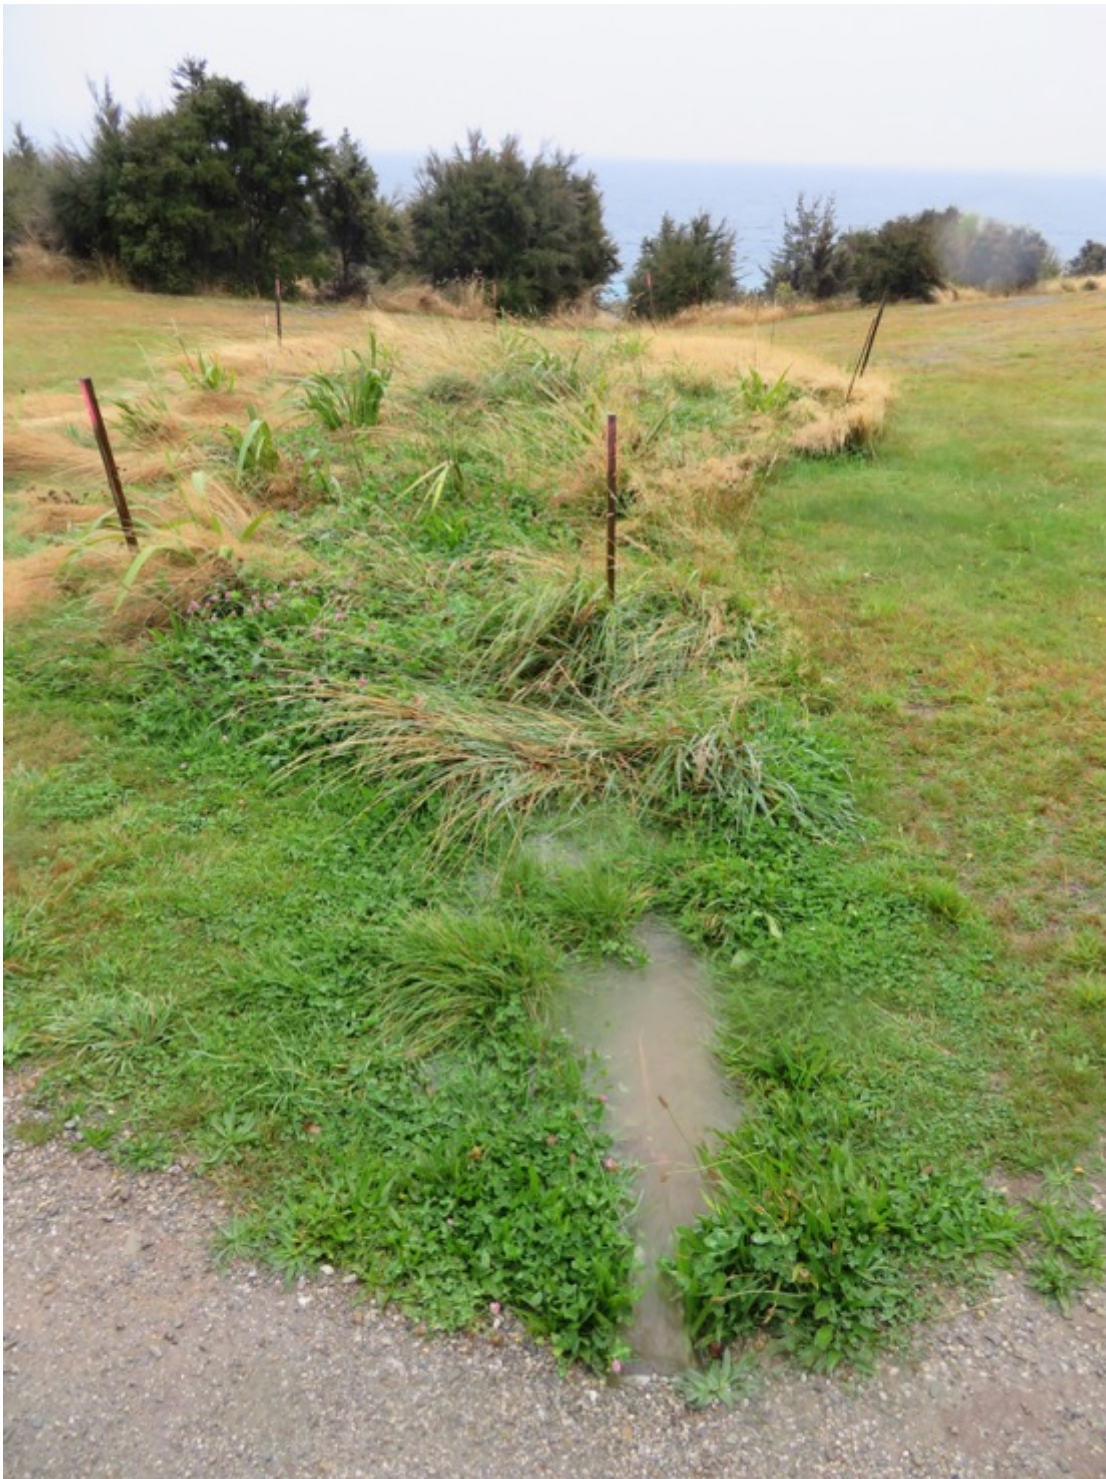
This is a small discharge that opens as it enters the reserve. The water then runs down a grass depression and terminates at the four wheel drive track to Kirsty's Beach. In the winter of 2018 the Lake Hāwea Foreshore Group sought to reduce the impact of this discharge by the planting of swamp flax (Fig 4.1) in the top half of the grass depression. These plantings have flourished and will provide a benefit in the future. Nevertheless water discharge north of these plantings is causing scouring of the 4WD track down to Kirsty's beach (Fig 4.2). During moderate rainfall there is ponding at Kirsty's beach (Fig 4.3). The flat grassy area at Kirsty's beach catches the erosion from the 4wd track.

Figure 4.1: Kirsty's Beach: Swamp Flax Plantings (26/3/19)

The existing flax planting could be extended. A gutter could be constructed to divert the water down the side of the access track.

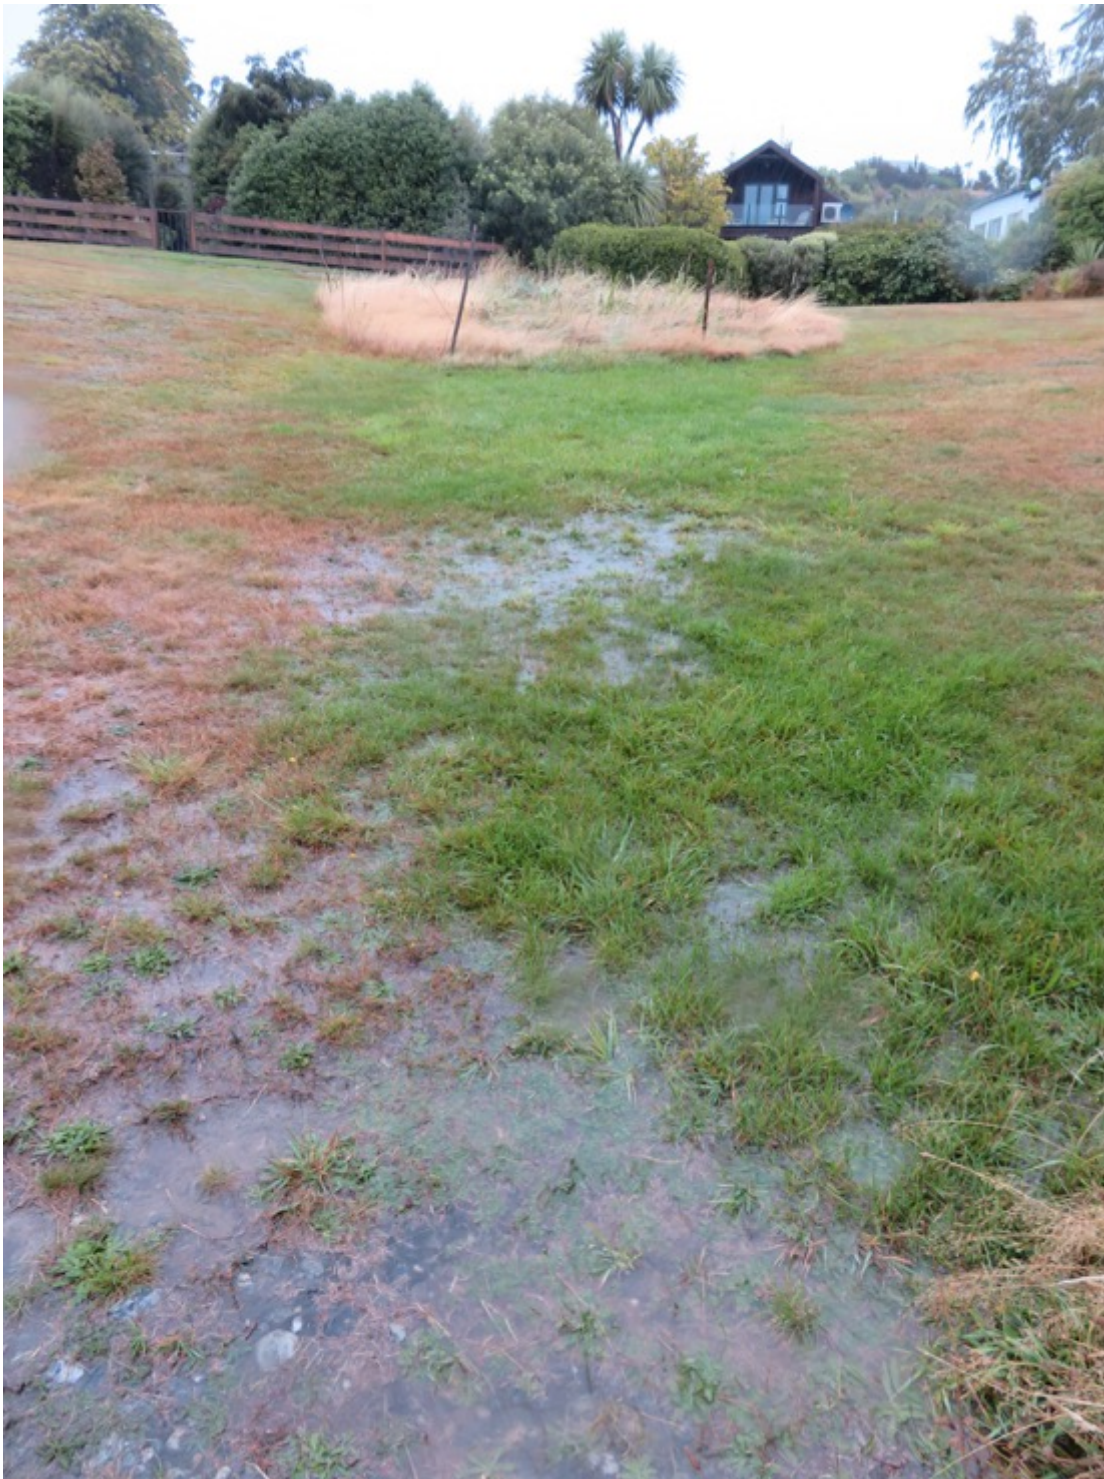
Figure 4.2 : Kirsty's Beach: flooding below planted area (26/3/19)

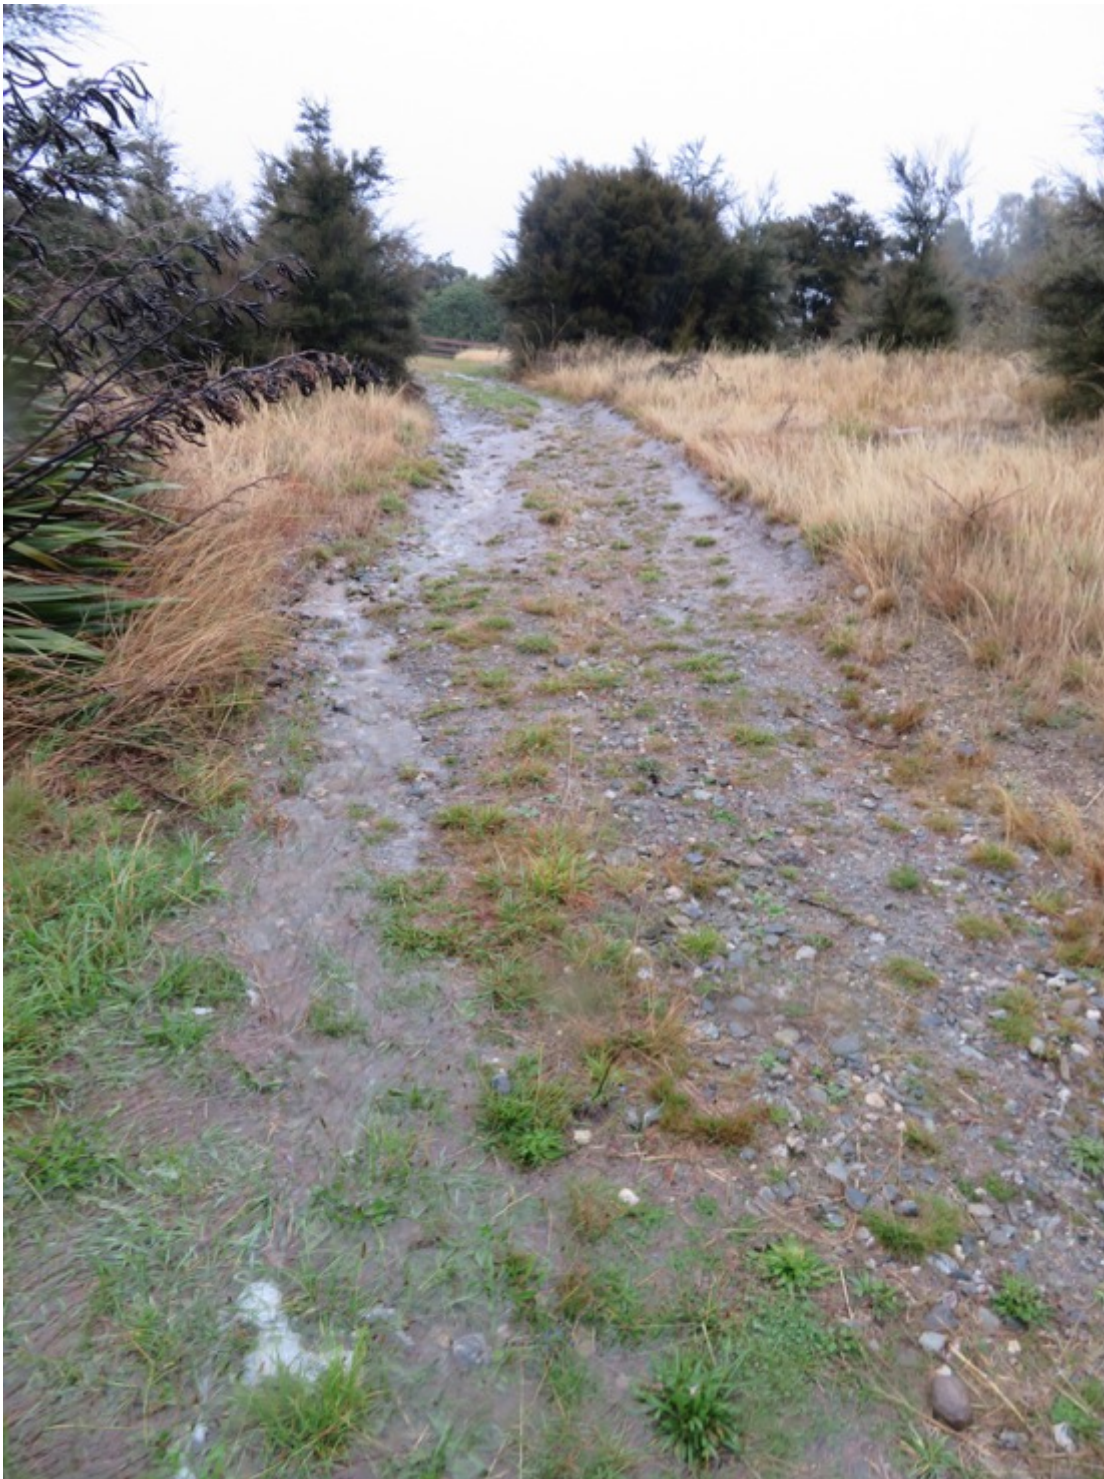
Figure 4.3: Water eroding 4wd access track to Kirsty's beach (26/3/19)

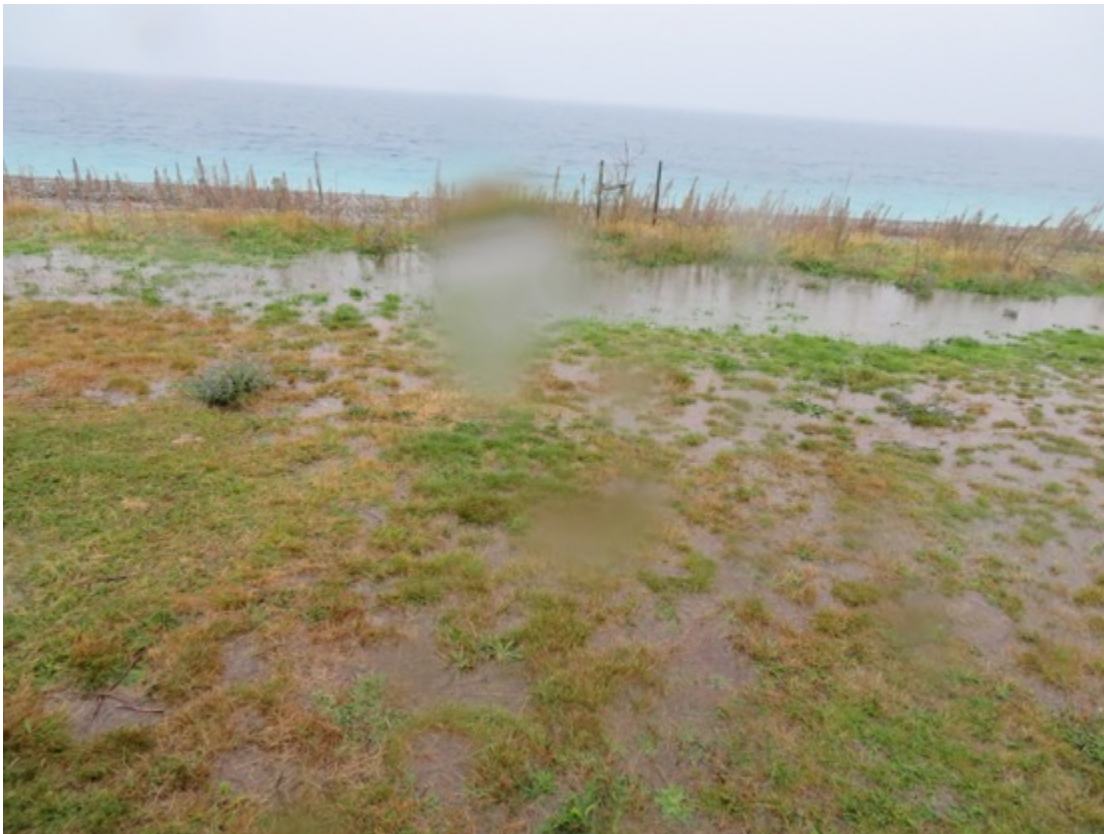
Figure 4.4: Kirsty's Beach: Ponding at the northern vegetation edge, below the 4WD access (26/3/19)

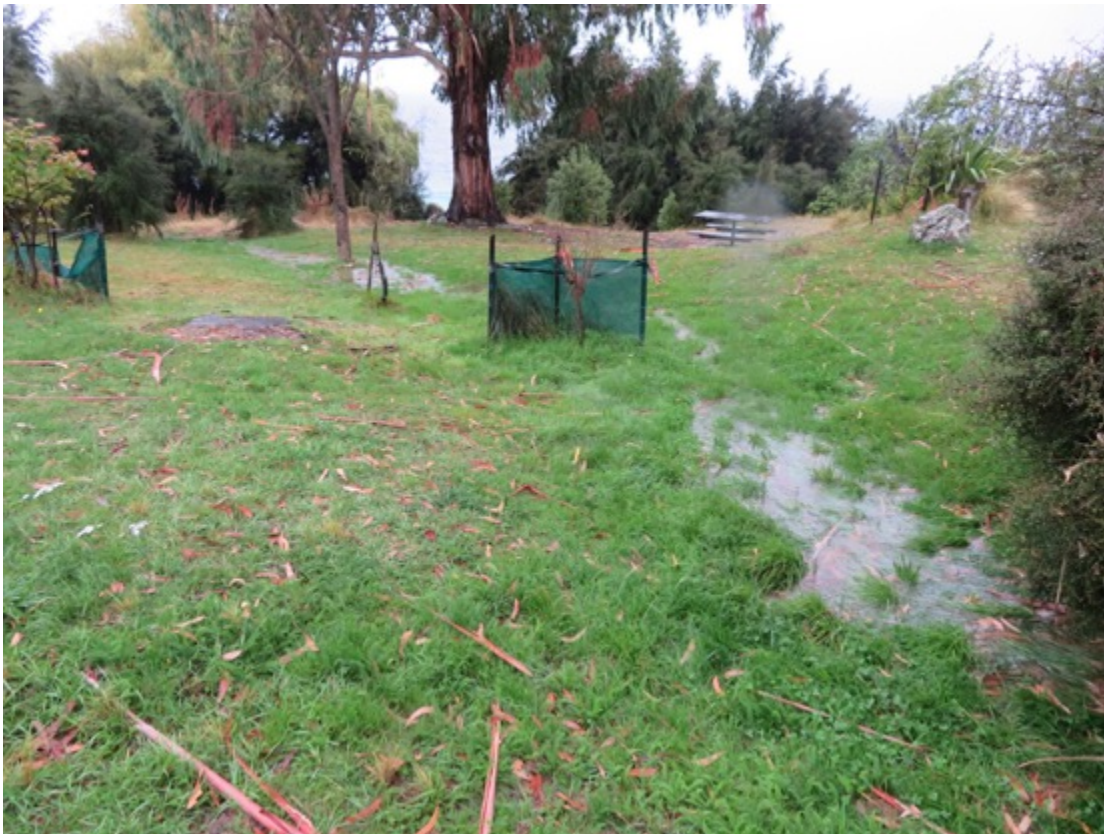
Stormwater comes off Lakeview Terrace and down an open drain on the left side (heading north) of the sealed drive accessing Kitesurfer's Beach. It turns west for a short distance and goes under the access road to the Esplanade thence across grass (Fig 3.1) where it pools under a willow before draining into the gravel foreshore (Fig 3.2). Apart from grass there is minimal mitigation.

Figure 5.1 Stormwater crossing grass below Esplanade access road (26/3/19)

The grass channel could be enhanced in much the same way as at Kirsty's Beach by the planting of swamp flax. Flax could also be planted under the willow tree.

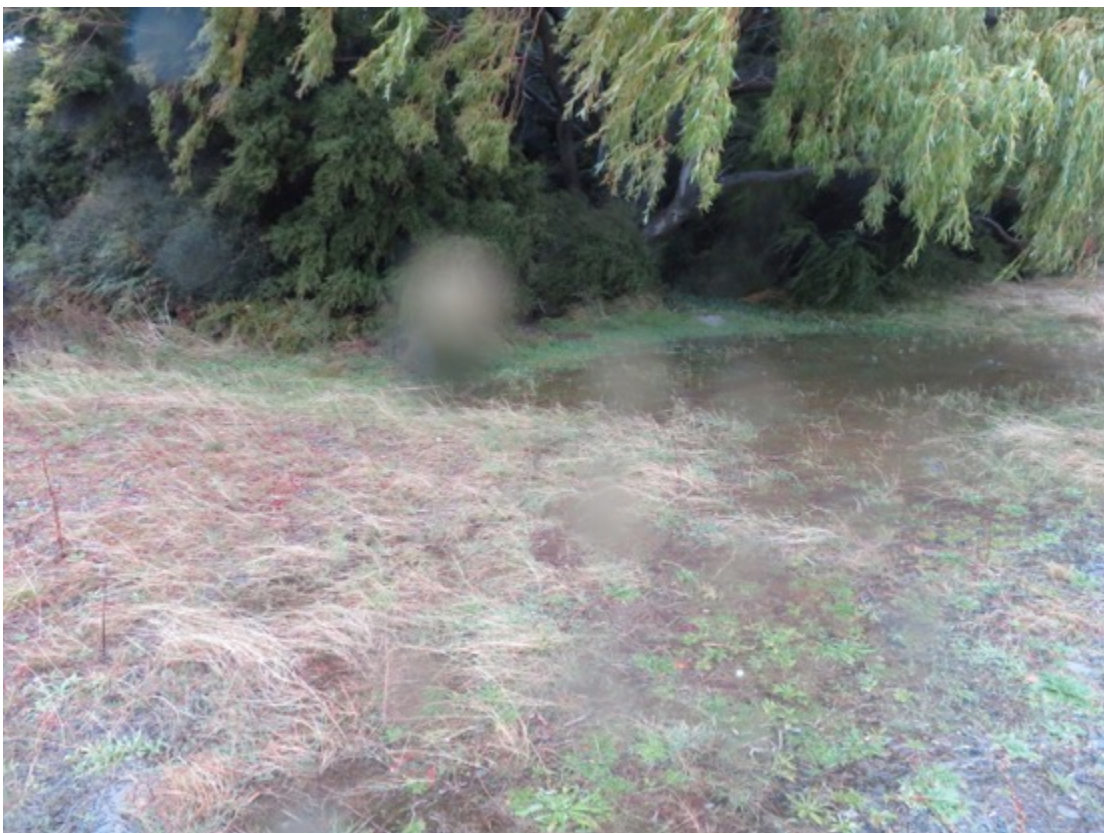
Figure 5.2. Ponding at termination of stormwater from Kitesurfers (26/3/19)

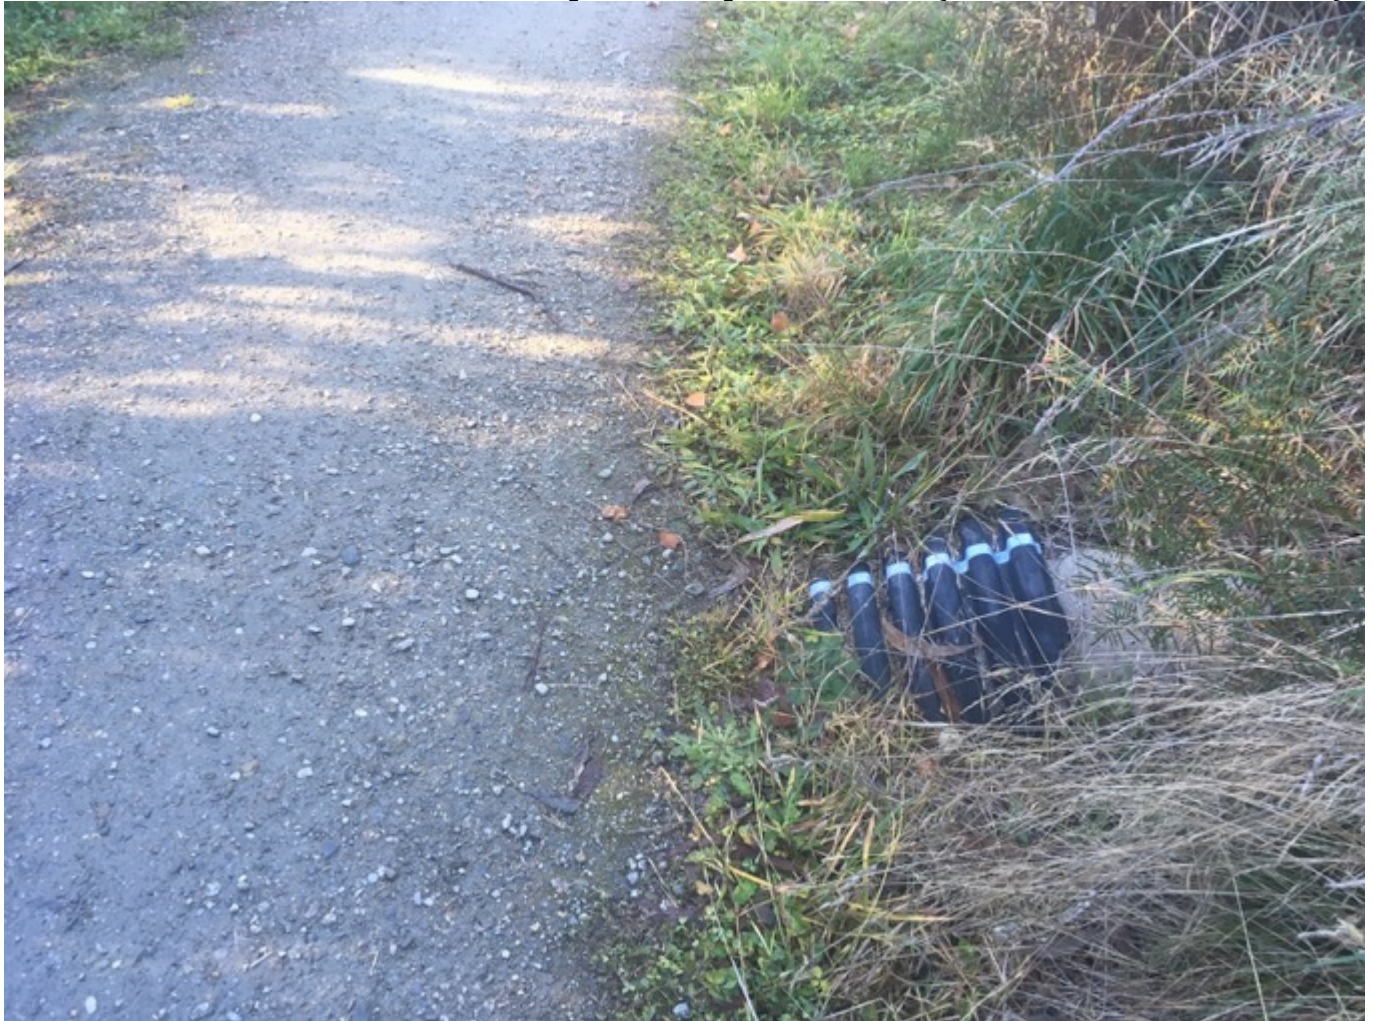
The drain is covered and runs under the Gladstone walking track. Immediately north of the track it becomes an open drain which discharges into dense bush down to the esplanade picnic area (extreme western end).

Fig 6.1: 130/134 Lakeview Terrace: Pipe running under Gladstone Track (24/5/19)

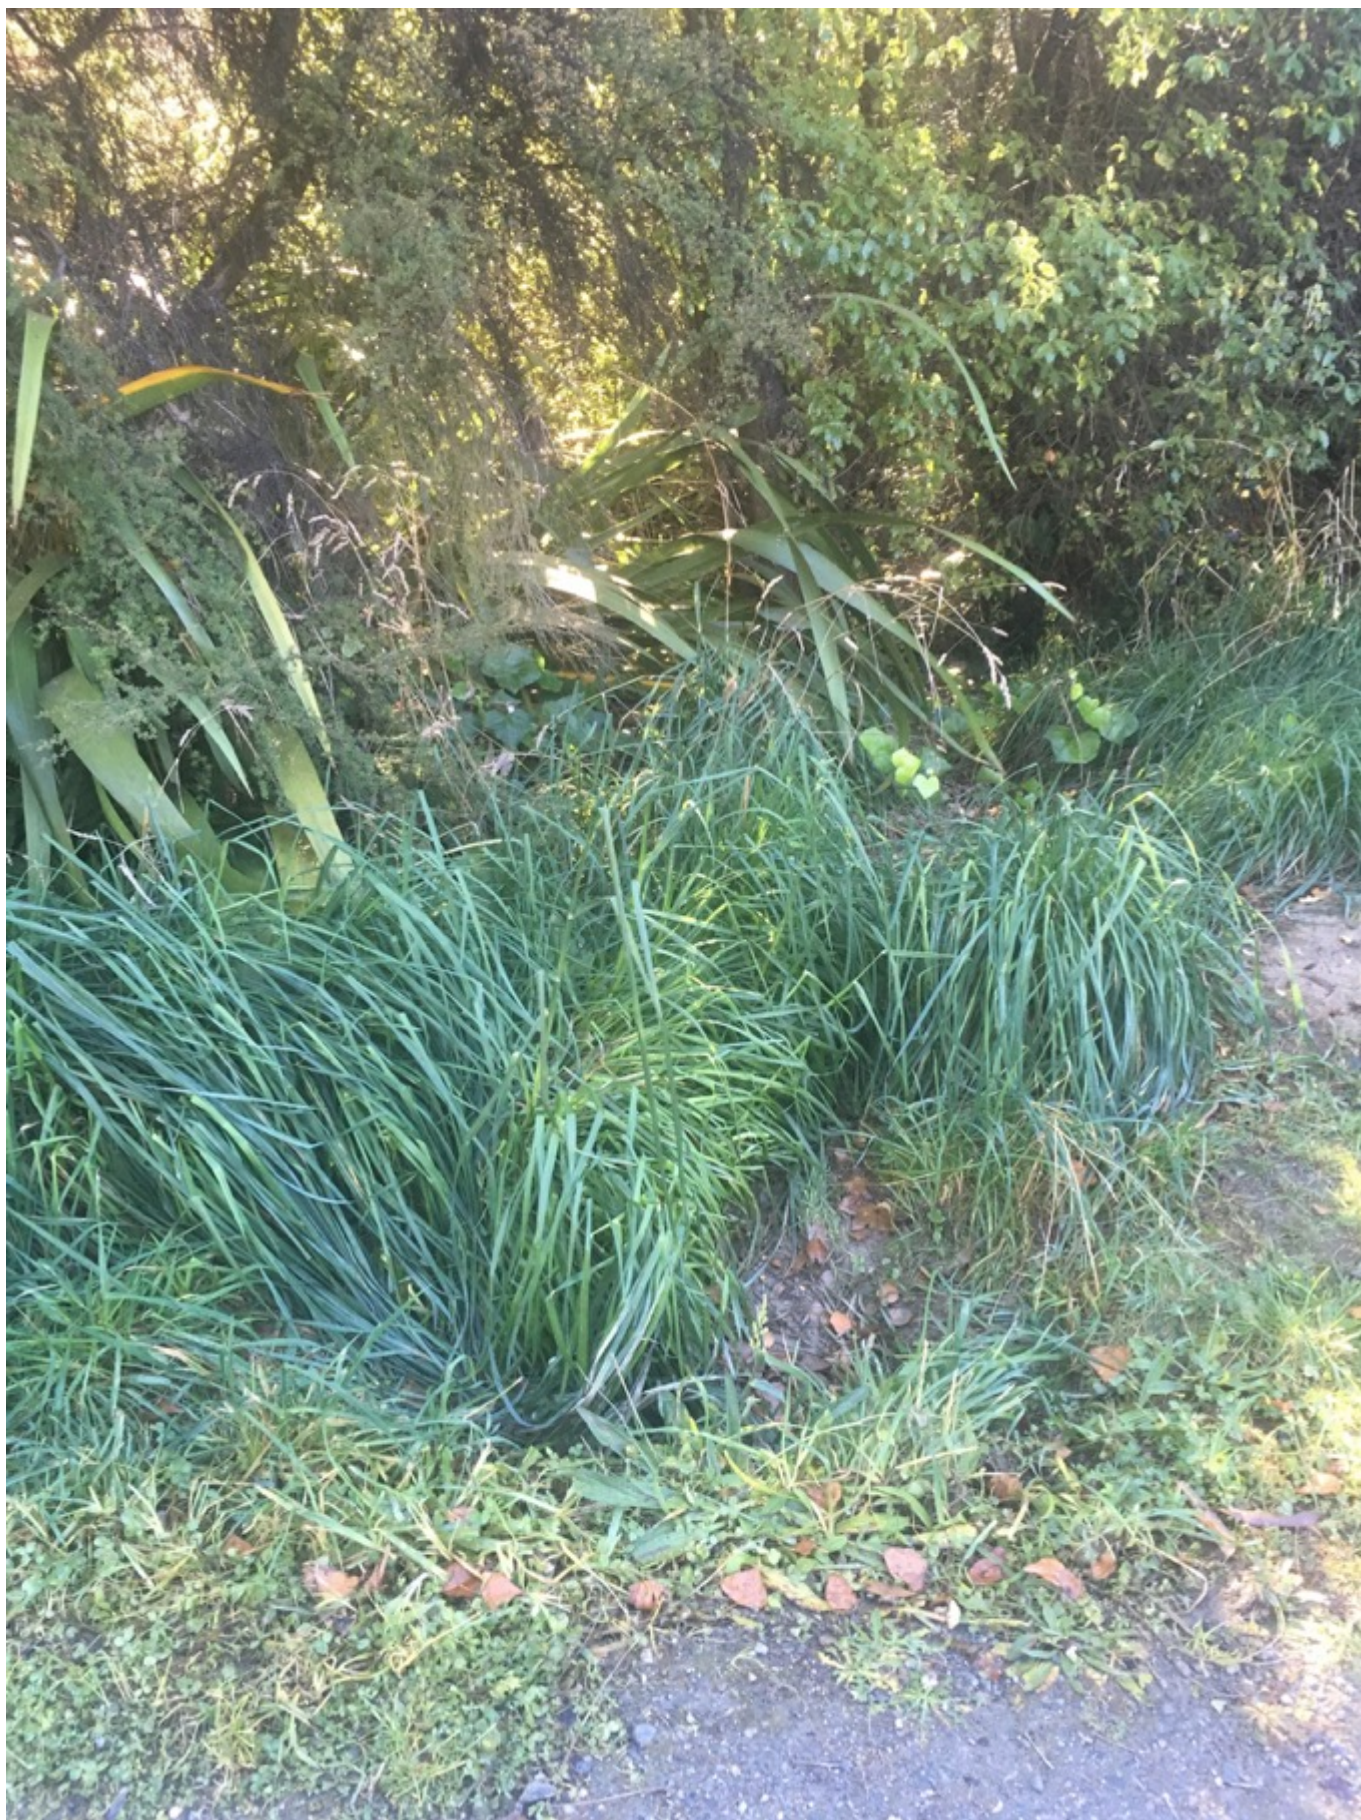
**Fig 6.2 130/134 Lakeview Terrace: open exit point for drain
(24/5/19)**

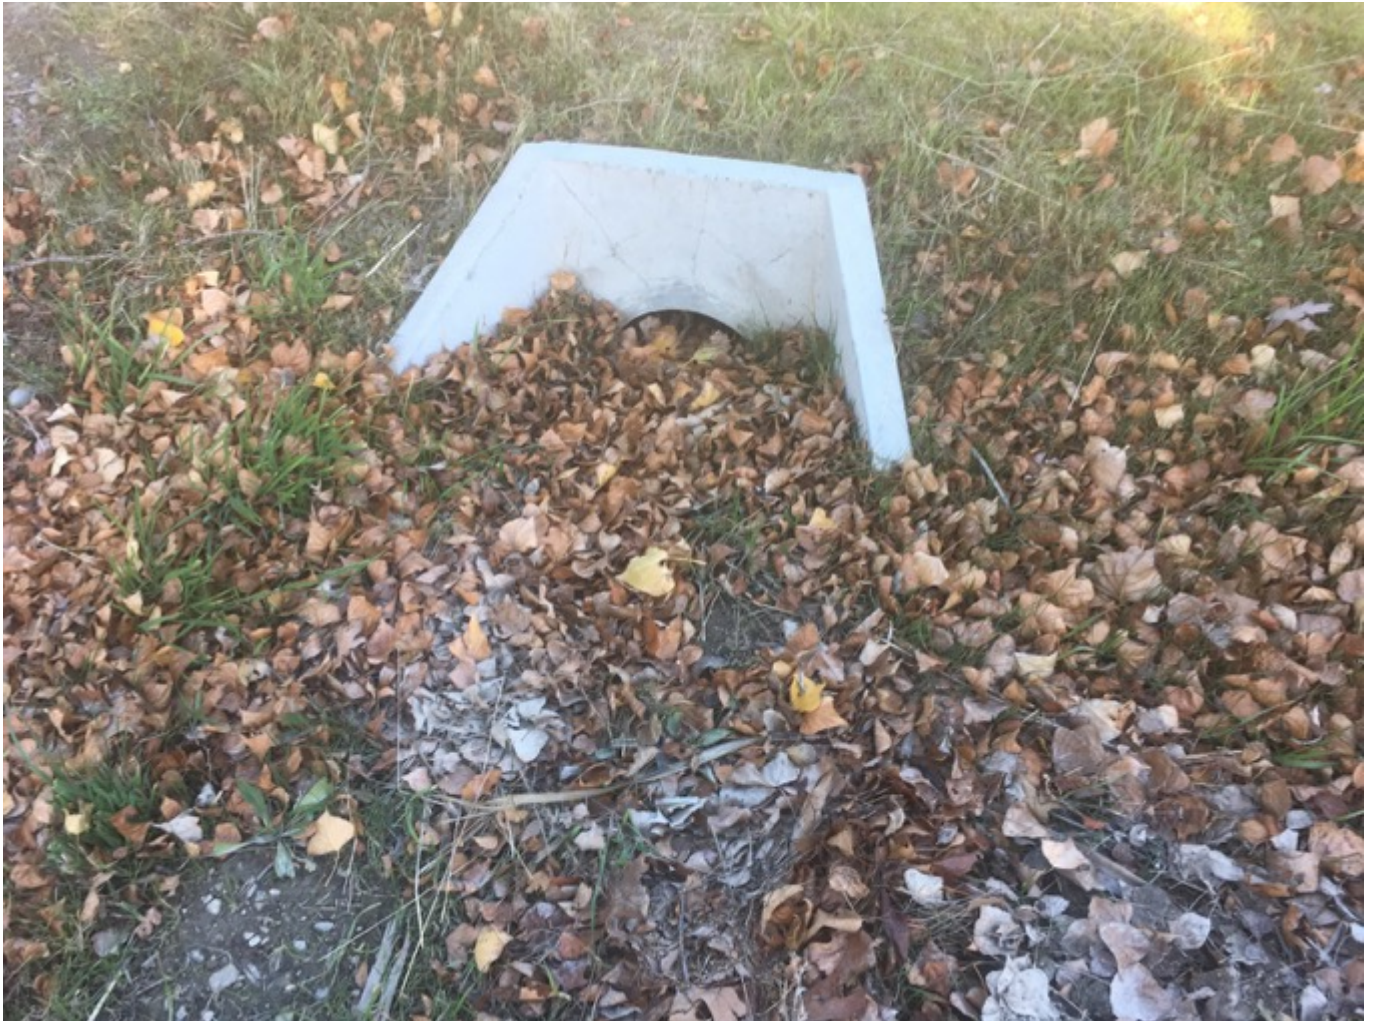
This drain is open soon after it enters the reserve (Fig7.1) and runs across an open grassy area (Fig 7.2) thence under the foreshore track then through dense vegetation to the foreshore.

Fig 7.1 86/90 Lakeview Terrace Stormwater exit (24/5/19)

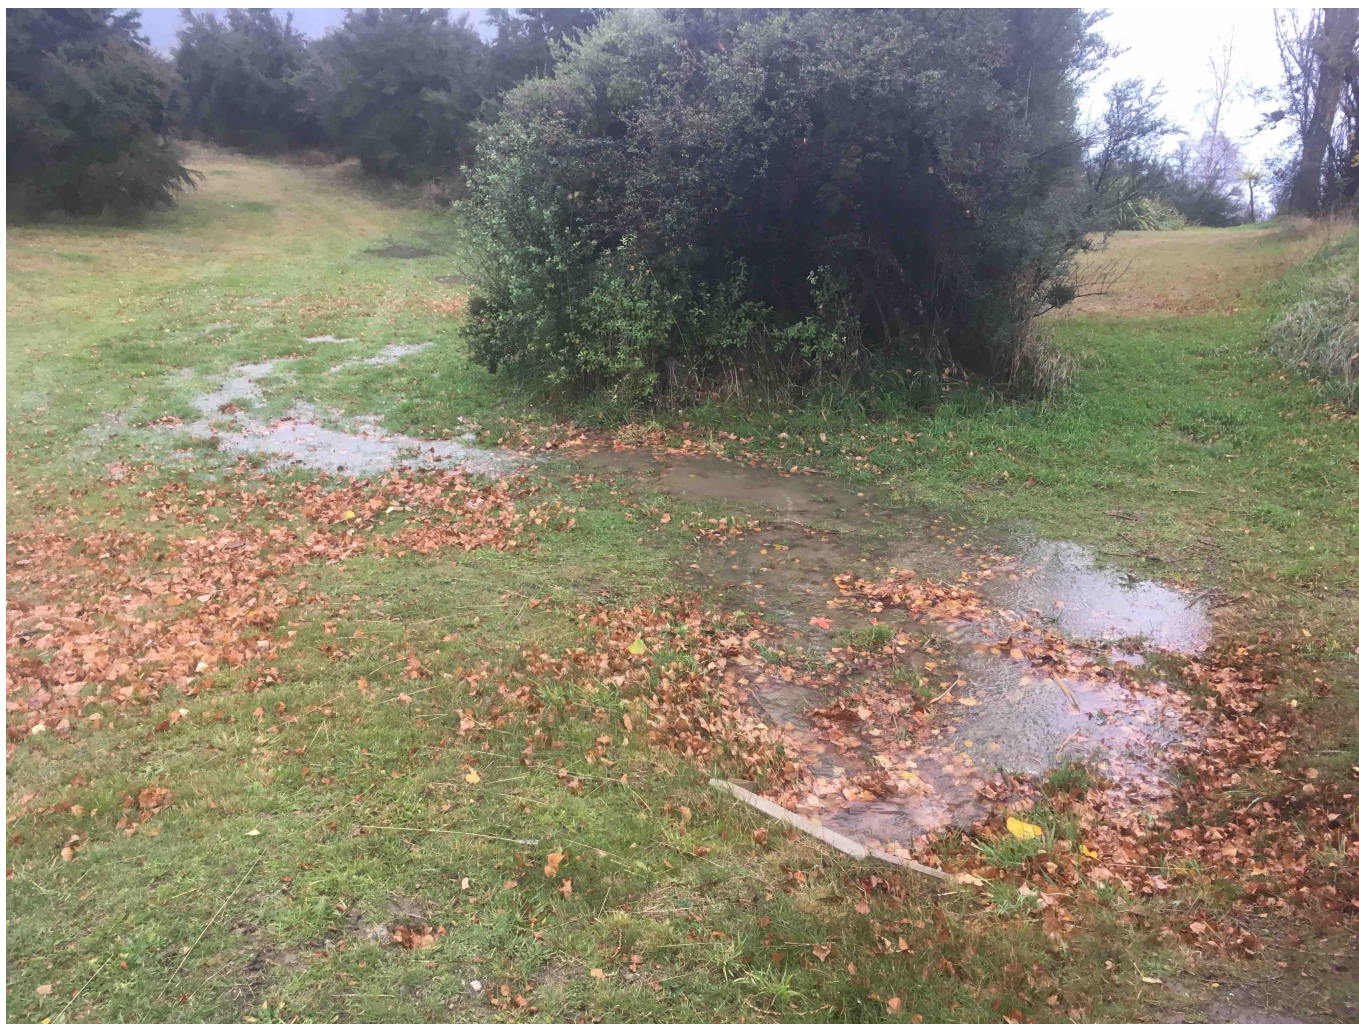
Fig 7.2 86/90 Lakeview Terrace (27/5/19)

Adverse effects could be further mitigated by planting swamp flax in the grassy area.

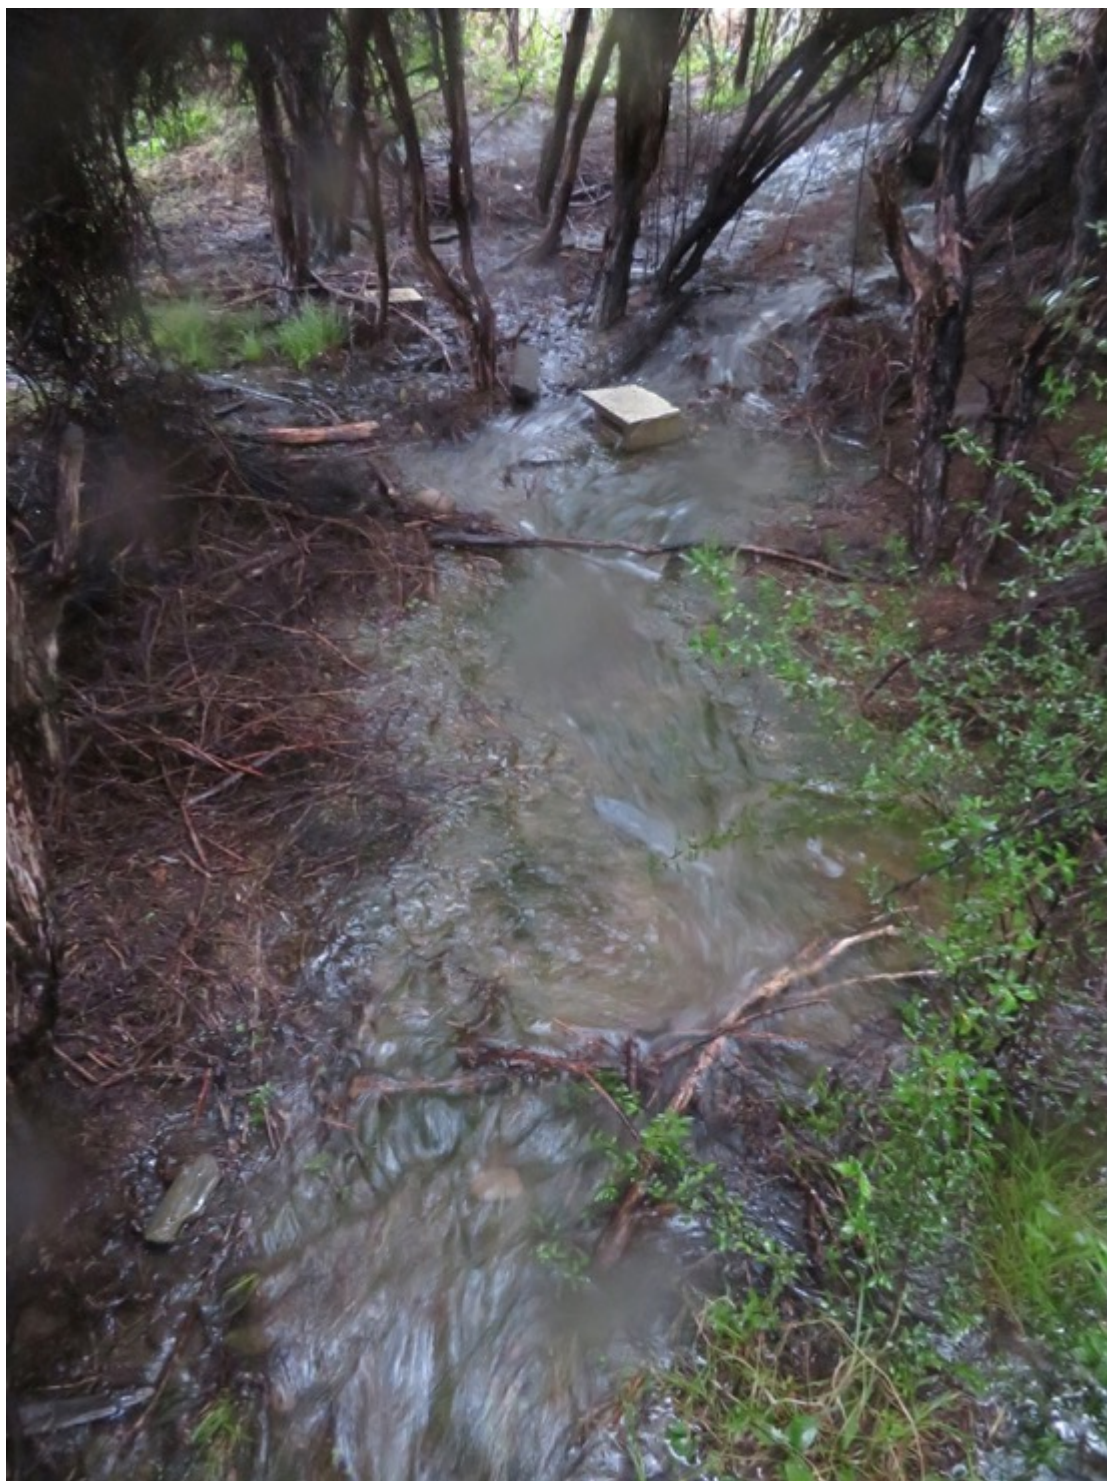
This drain goes under the walking track at which point it opens. It then flows through quite dense vegetation to the stony foreshore. As is evident from Fig 8.1 a significant volume of water flows through the vegetation

Fig 8.1 Ex 60/66 Lakeview Tce (26/3/19)

Vegetation options are limited given that there is excellent cover along the flow path. One flax was recently planted where the flow exits the bush. This planting could be complemented by others.

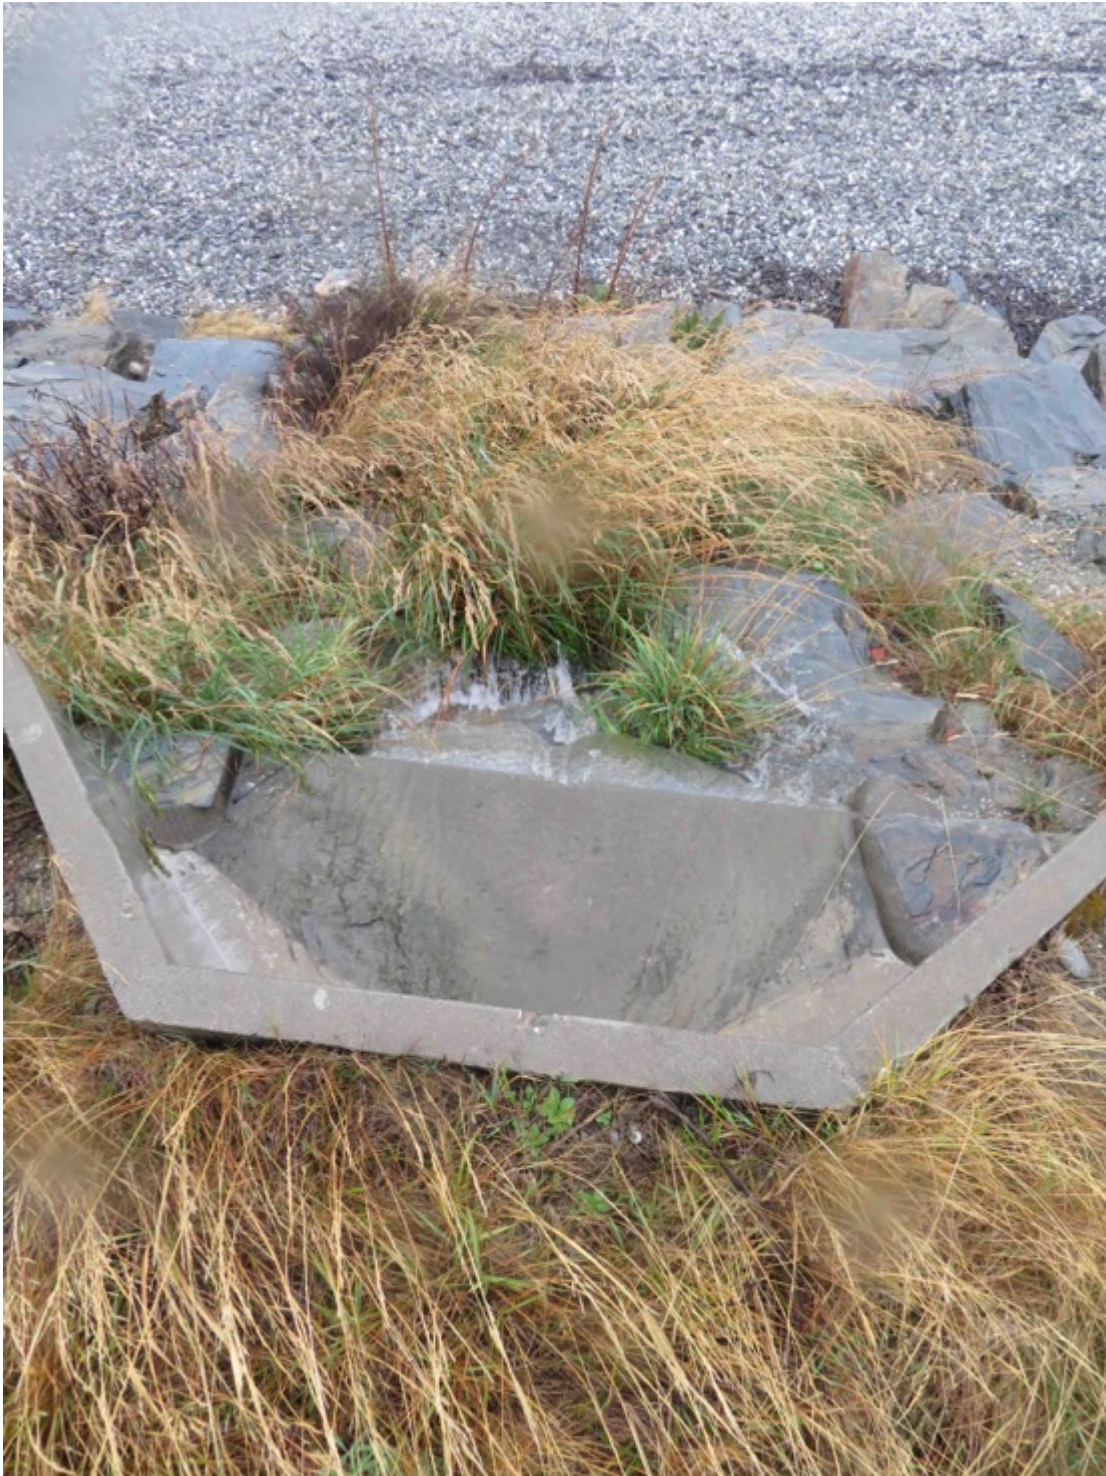
This drain is piped throughout its entire length. It exits just above the shoreline onto large schist rocks (Fig 9.1) that presumably were placed to

reduce the risk of erosion. That strategy has been effective. The water is not filtered in any way prior to exiting on the foreshore.

Fig 9.1 34/40 Skinner Terrace (26/3/19)

Mitigation is challenging given the large rocks around the exit. Nevertheless there is sufficient soil and gravel to allow the establishment of several plants.
