Mitigation of the adverse effects of Lake Hāwea Township stormwater entering Lake Hāwea

Prepared by John Langley & Don Robertson

On behalf of the Guardians of Lake Hāwea

17 June 2019

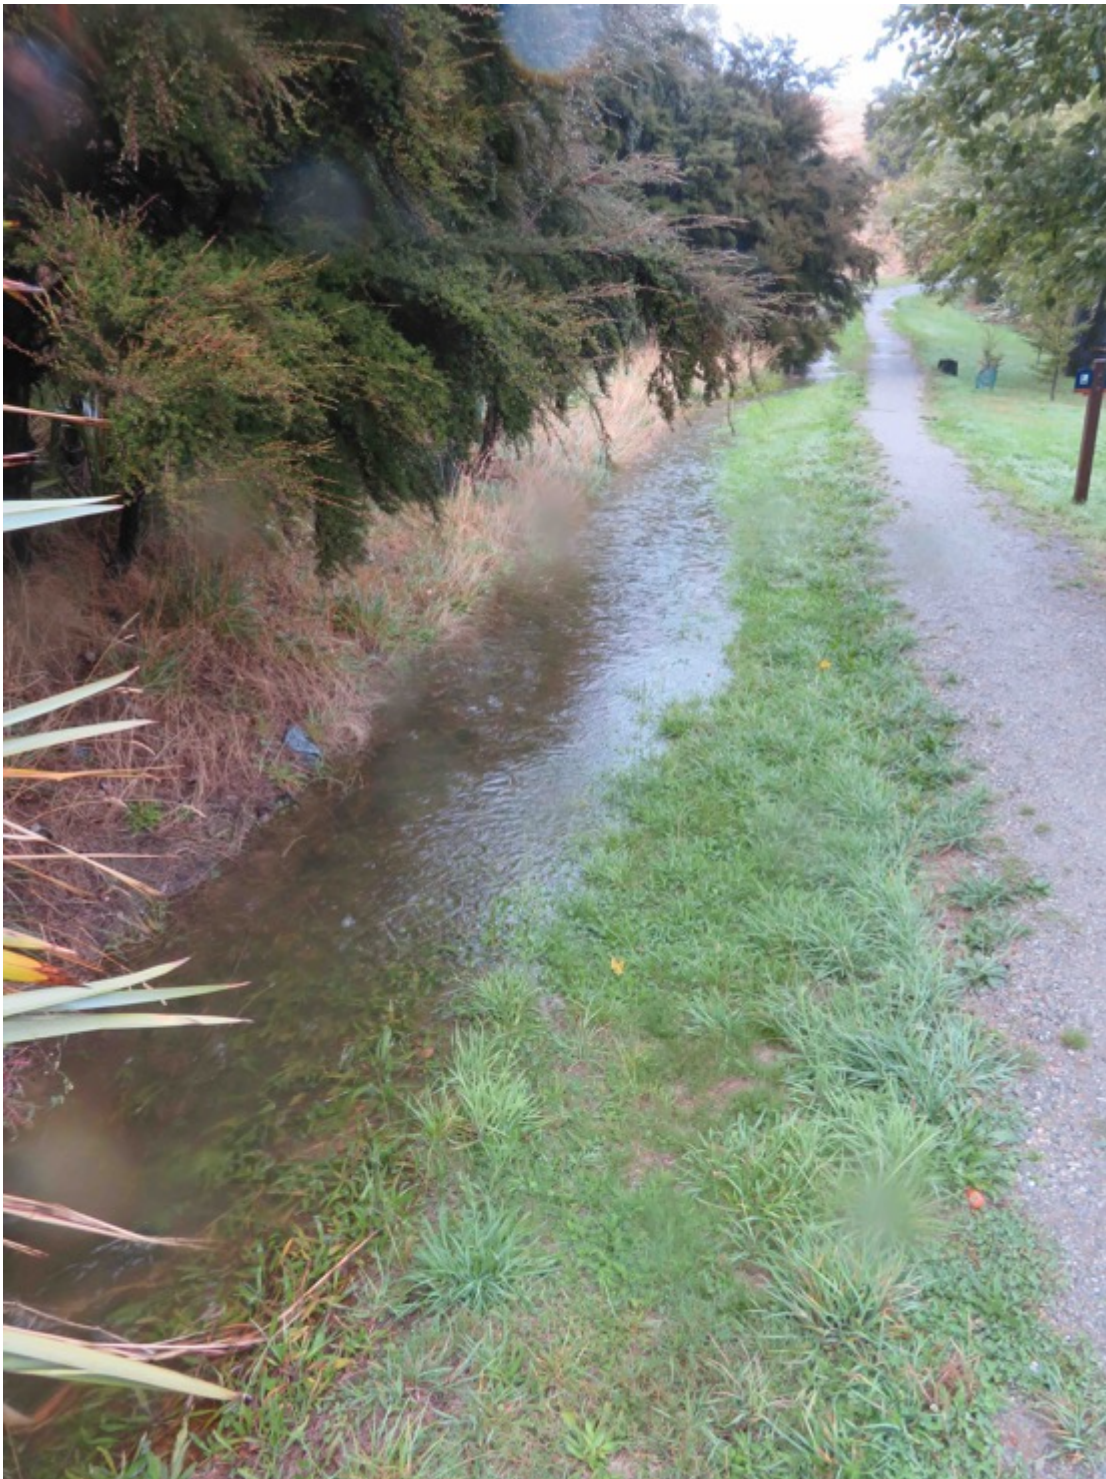
There is an open stormwater drain that runs down the bank to the west of the vehicle entrance to Scotts beach. It passes the pump house then runs parallel to a walking track (Fig 7. 1), goes under the foreshore track and exits onto the shoreline (Fig 7.2).

Fig 10.1 Open drain Scotts beach (26/3/19)

There is an excellent opportunity to form a small wetland. The walking track could be diverted such that it forms an arc to the west of the open drain. The area between the arc and the existing drain could be excavated slightly and then planted with swamp flax.

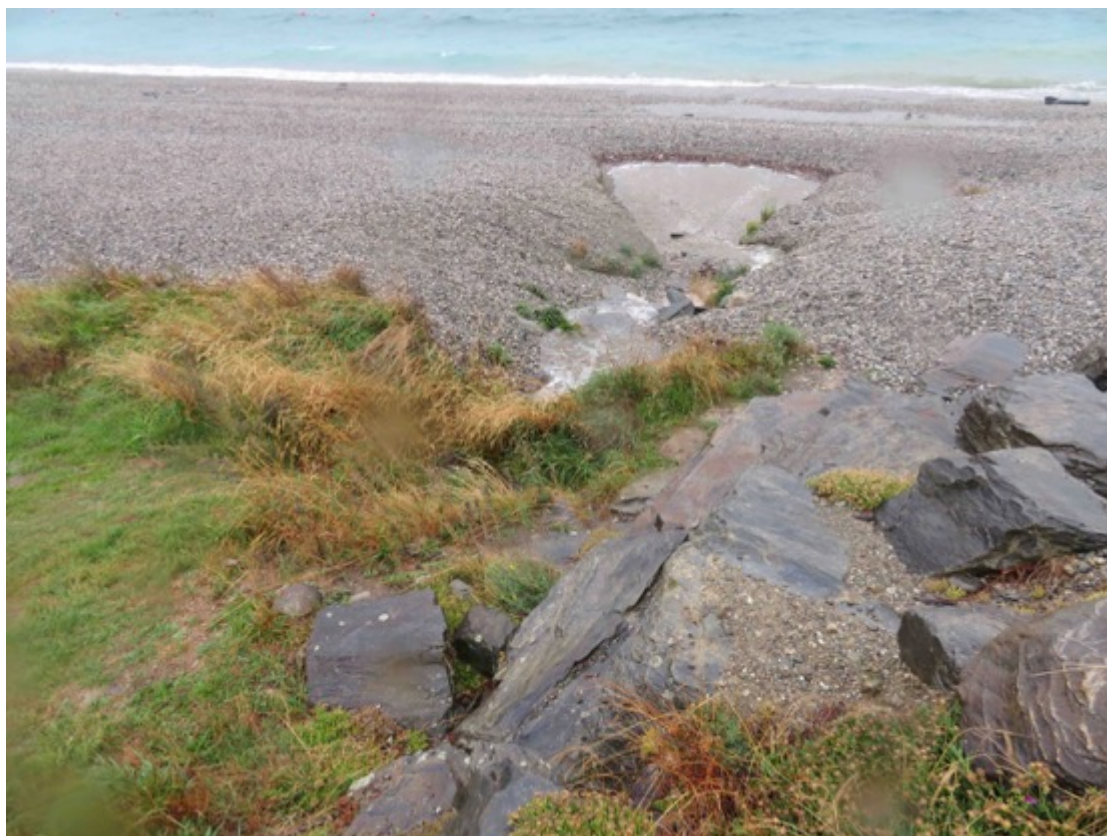
There is minimal vegetation mitigation and the stormwater forms a significant gut on the gravel foreshore. At times of high rainfall the drain cannot cope with the water flow and the water comes across the track and onto the picnic area (west of the track). There was a large natural sink-hole where the existing picnic area is. This was filled in following the 1990s flood and grassed over to make a picnic area.

Figure 10.2 Scotts beach: scouring (26/3/19)

The gut on the beach is moderated to some degree when the lake level is high. This seems to be an increasingly rare event. The issue could be addressed by placing large rocks at the mouth of the drain to reduce the scouring.

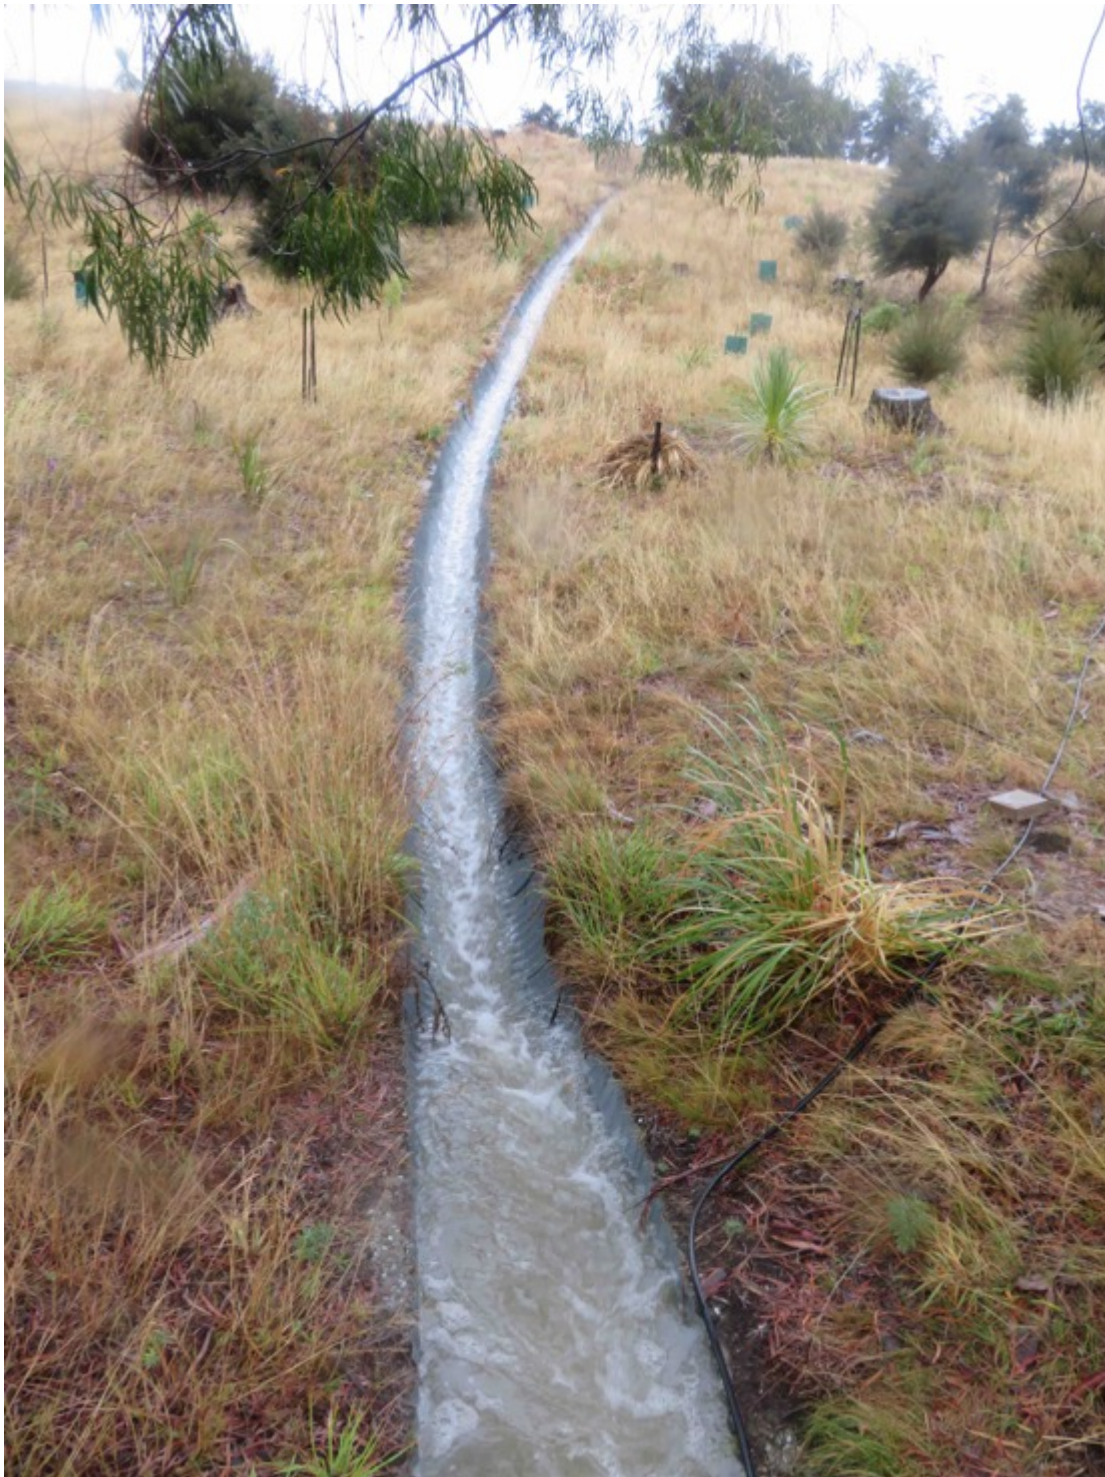
The stormwater enters the reserve down a steep slope by way of an open drain that is corrugated to reduce the energy of the flow (Fig 11.1). The water passes under a small foot-bridge on the foreshore track. Soon after, the corrugated drain stops and the water then runs across a flat area before cascading over the cliff face at various points. The water is causing major erosion of the cliff face (Fig 11.2) and that in turn is resulting in a

Fig 11.1 Open stormwater drain from Flora Dora Parade to Flora Dora terrace(26/3/19)

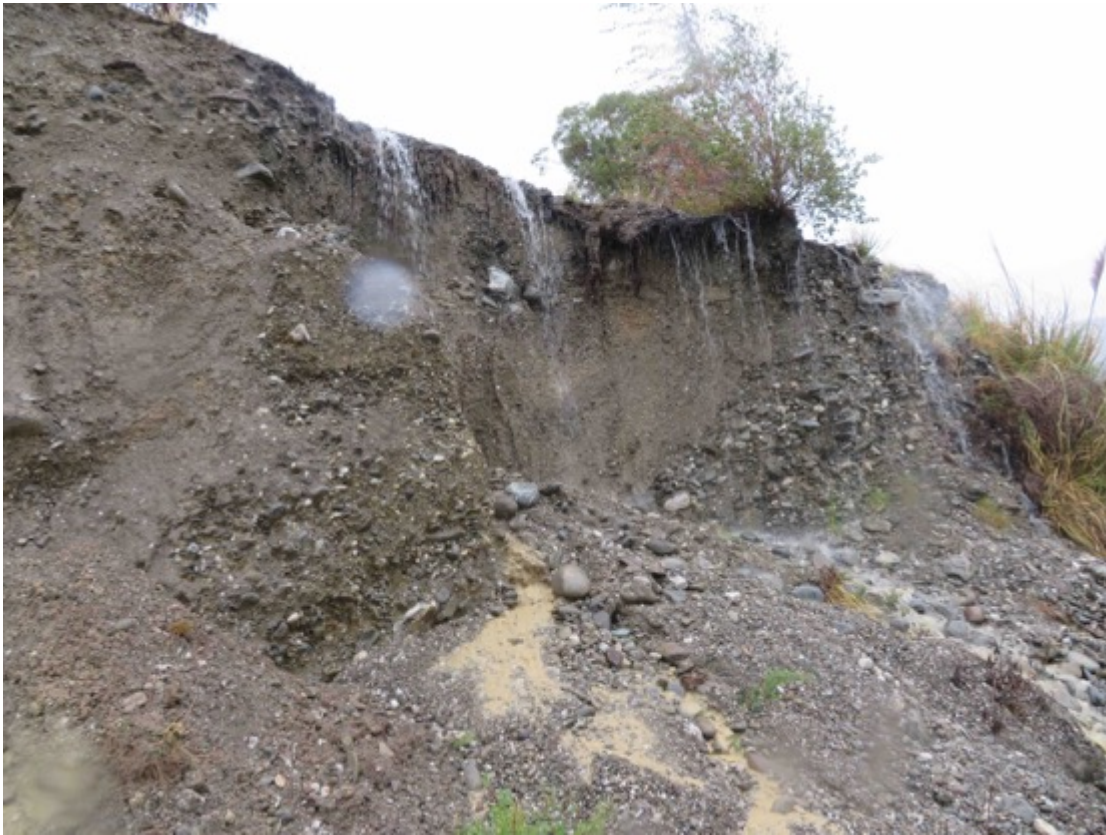
Fig 11.2 Flora Dora Terrace: eroding cliff (26/3/19)

There is an urgent need to address the erosion of the cliff face. One option would be to create a series of deep channels parallel to the fence line filled with gravel.

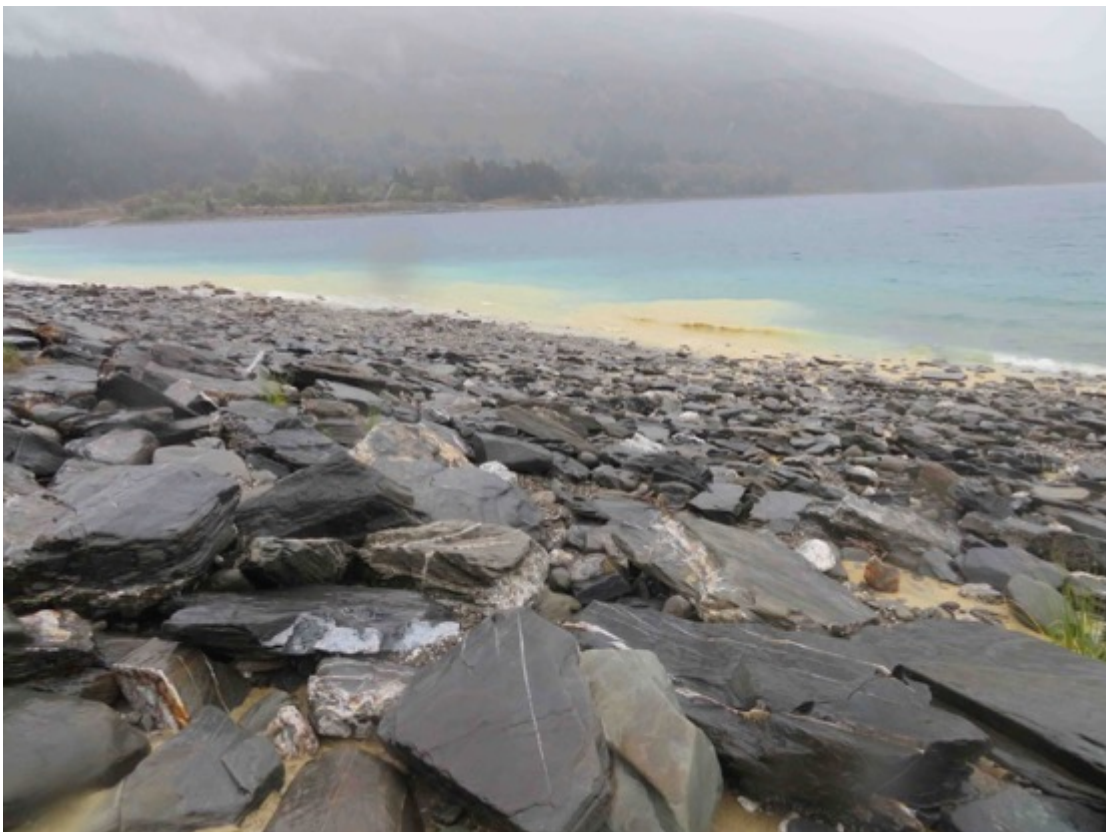
silty plume (Fig 11.3) in the lake. The Thursday Group has sought to mitigate the adverse effects by creating small diversion channels and with flax plantings (Fig 11.4 a & b), but these efforts are insufficient given the flow during even mild rain conditions.

Fig 11.3 Silt Plume caused by eroding Flora Dora Terrace cliff erosion (26/3/19)

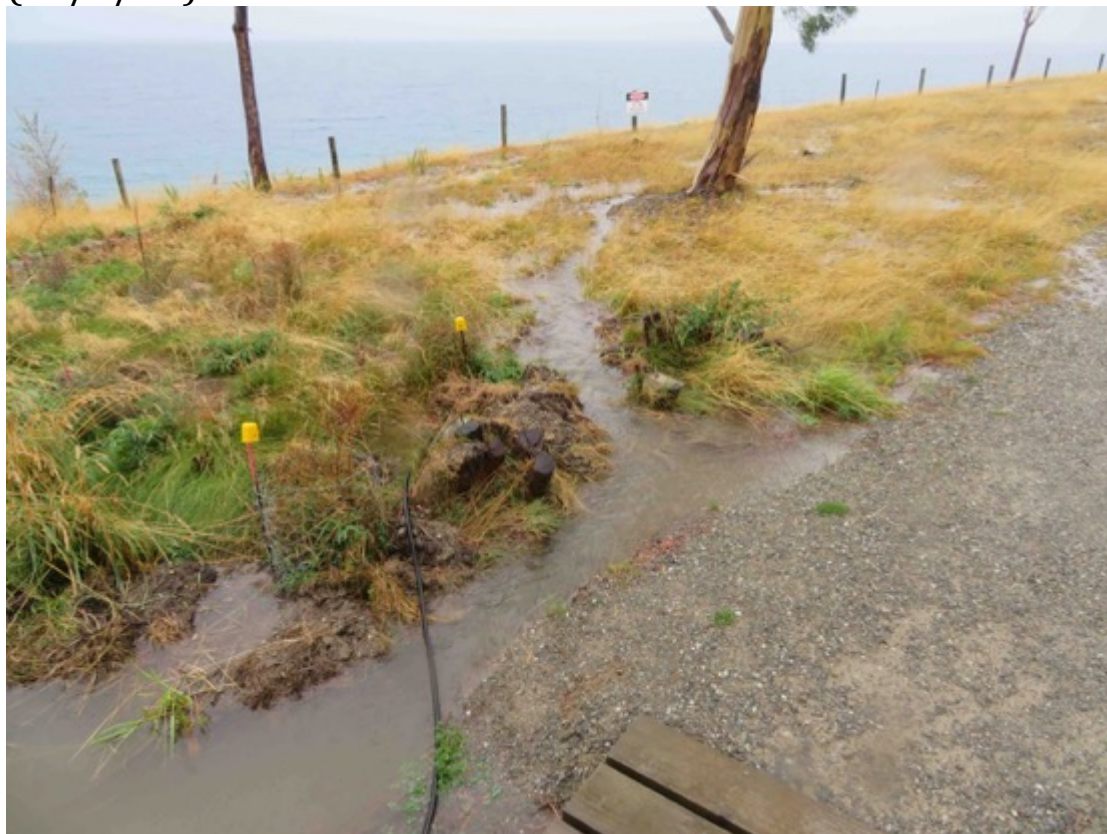
Fig 11.4a Diversion and planting (26/3/19)

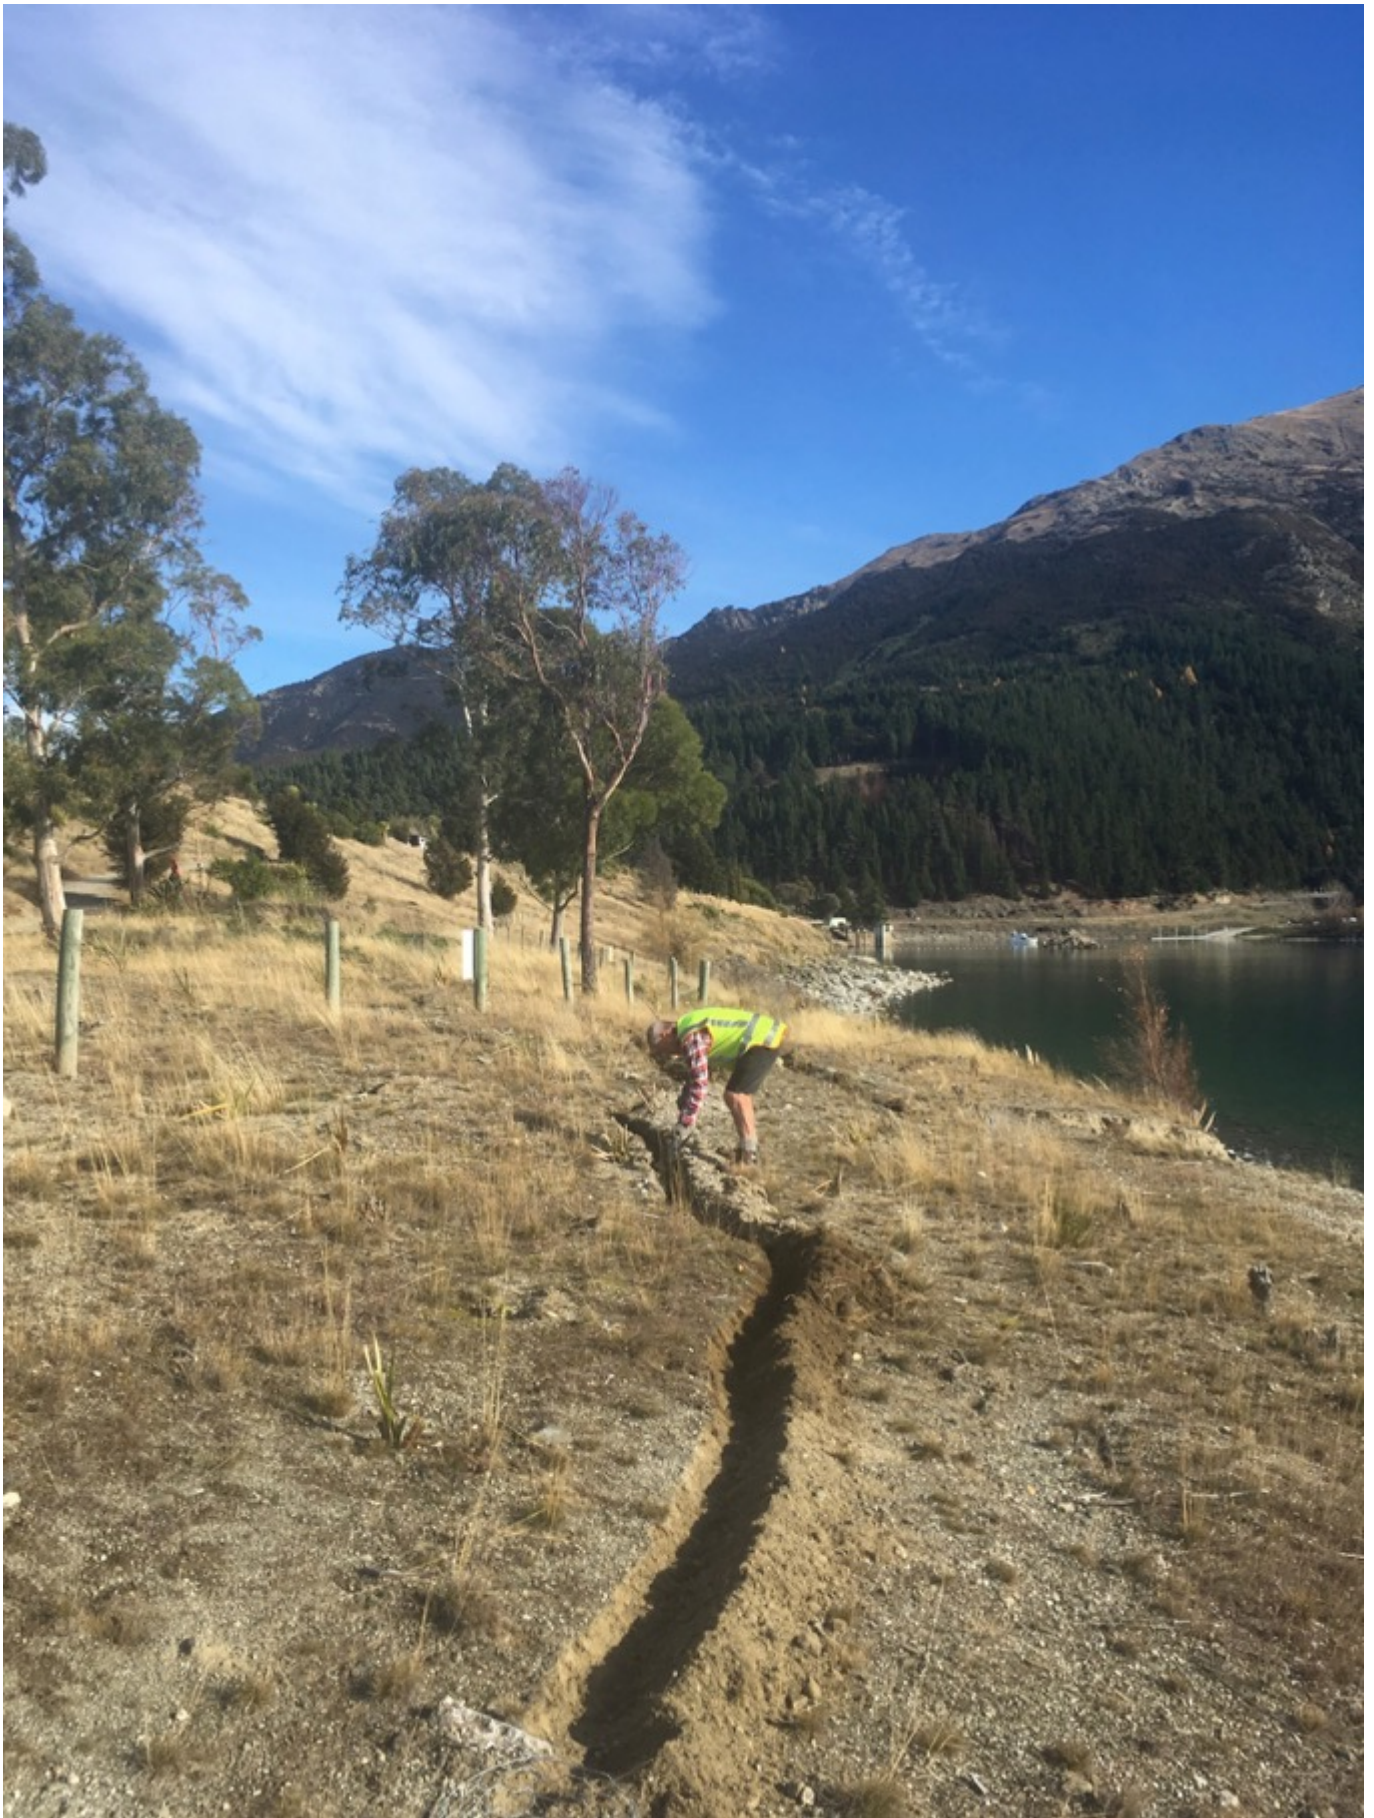
Figure 11.4b Diversion (23 May 2019)
